NASA Technical Memorandum 102681
USAAVSCOM Technical Report 90-B-003

Behavior of Composite/Metal Aircraft Structural Elements and Components Under Crash Type Loads--What Are They Telling Us?

May 1990

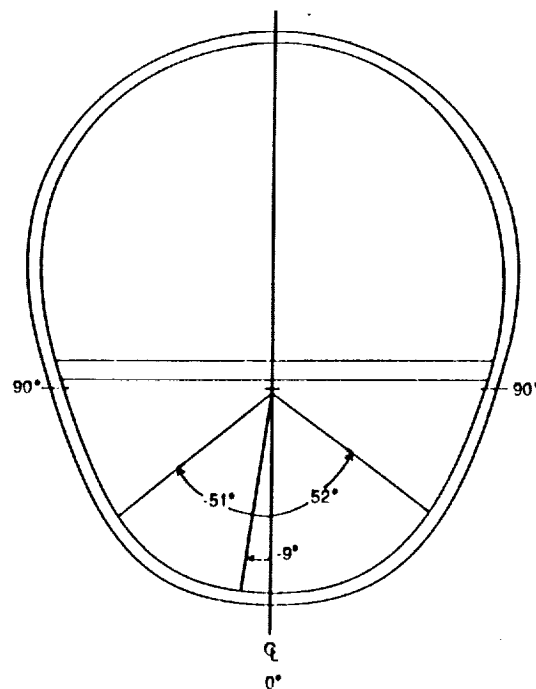
(c) Angular location of failures.

Dynamic tests.- Structural damage of the transport aircraft structures resulting from the 20 ft/s drop tests is shown in figure 8(a) and (b). The damage to the transport sections was confined to the lower fuselage below the floor level. Under the vertical impact of 20 ft/s, all seven of the frames ruptured near the bottom impact point. Plastic hinges formed in each frame along both sides of the fuselage about 50 degrees up the circumference from the bottom contact point (See figure 8(c)). The crush of the lower fuselage was approximately 22-23 inches at the front end and 18-19 inches at the rear for the section taken from forward of the wing location (figure 8(a)) whereas for the aft section (figure 8(b)) the crushing was about 14 inches in front and 18 inches in the rear. Although the aircraft structures are metal and the failures discussed above involve plastic deformations with some tearing of the metal rather than brittle fractures, the general observed failure pattern and locations for the transport fuselage sections will be shown to be quite similar to the results of the composite frames and subfloors discussed later.

Figure 8. - Structural damage to metal aircraft structures resulting from impact tests.

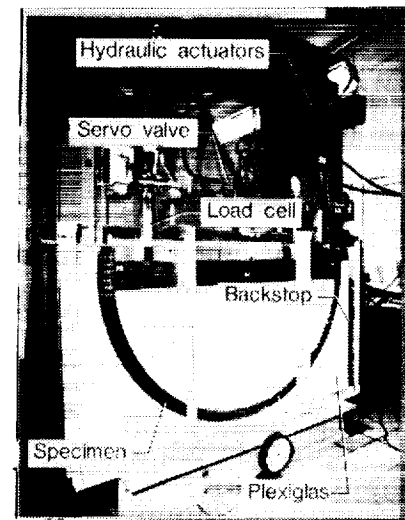
(a) Static test apparatus.

Static tests.- Results from the static test of a semi-circular frame with a Z cross-section²⁷ are presented in Figure 11. A photograph of the static test apparatus in figure 11(a) shows that the splice plate was at the load point. Consequently, the frame failed just outside the doubler splice plate area by a complete fracture across the Z-section. Load-deflection data and the location of failures of the frame are shown in figure 11(b). The load-deflection data show a saw-toothed behavior of loading and unloading. The load increased linearly until initial failure, then falls off to under 600 pounds force. Subsequent loading of the frame after initial failure was at a new, reduced stiffness. Second and third fractures occurred up the side again at about 54 and 58 degrees under continued loading as may be noted in the sketch at the right of figure 11(b). Photographic data in figure 10(c) shows that the initial failure was induced by a local buckling of the frame which occurred at about 18 degrees from the bottom loading point outside the splice plate area.

Figure 11. - Static results from tests of single composite Z-frame.

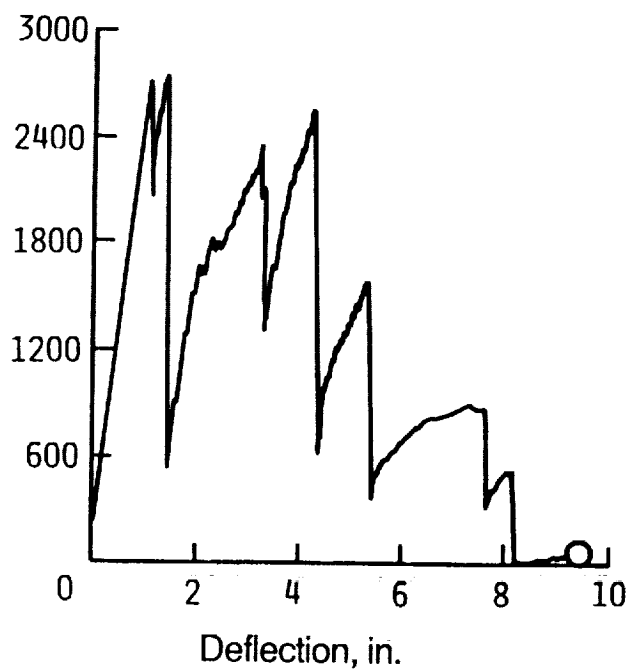
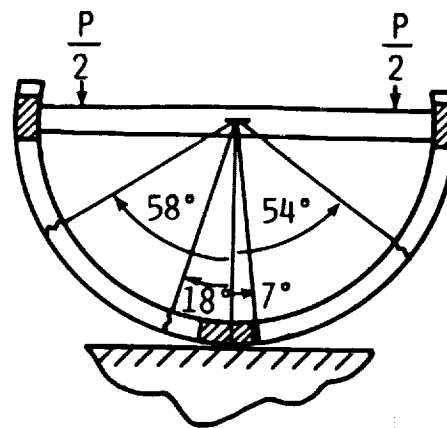
(b) Load-displacement and failure locations.

Furthermore, a comparison of the analytical cases (figure 12(a)) with the actual static load-deflection of the Z-section (figure 11(b)) indicates very similar load-deflection behavior patterns as discussed above. Although the Z-frame had no skin, if the ends jam together (as they did in several cases), the boundary is effectively between the skin stiffened case and a guided boundary. Thus, the predicted maximum moment location in the simple beam-frame model at about 50 degrees (See figure 12(b)) agrees well with the 54 and 58 degree failure locations in the experiment with the Z-section frame.

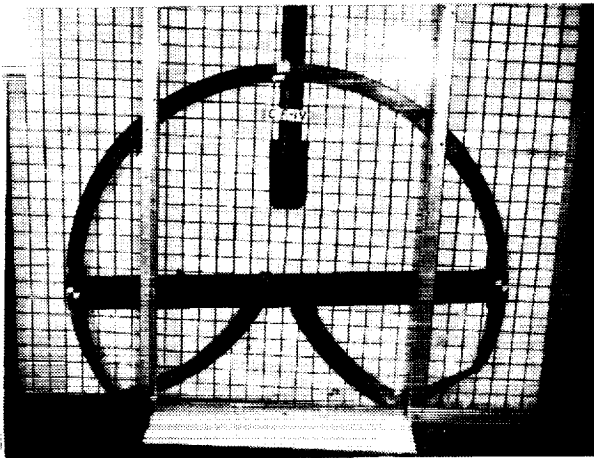
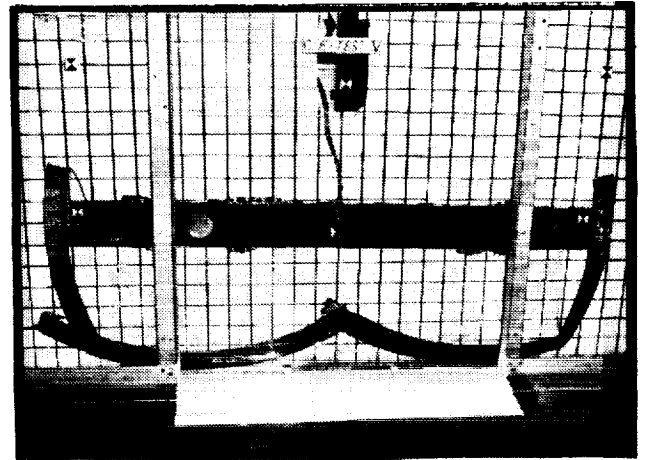
(a) Photographs of failed frames.

Dynamic tests. Results from reference 29 on the dynamic studies of the response of composite frames are shown in Figure 13. Photographs of the failed Z-frames in the drop apparatus are shown in Figure 13(a). It should be noted, the splice plates joining the segments of the frame are 45 degrees up the circumference from the point of impact. As shown in figure 13(b), complete failures (fractures) of the Z-section frames occurred at the bottom and approximately 60 degrees from the bottom. It appears that the presence of the splice plates moved the top failure points up a few degrees (to about the 60 degree locations).

Figure 13. - Behavior of composite Z-frame under impact loading.

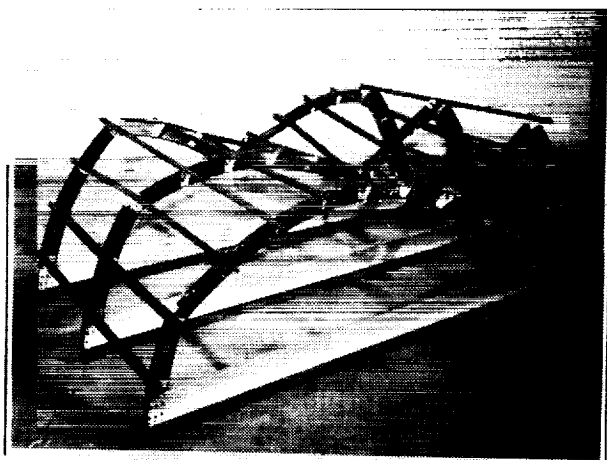
(a) Failed composite skeleton subfloor.

Static tests. Experimental results³⁰ of the skeleton subfloor specimen following a static test are shown in Figure 14. As noted in figure 14(a) and (b), failures on the three Z-section frames occurred at 13 discrete locations. Unlike the unnotched single Z-frame, the failures in this specimen occurred at notches (which served as stress risers) in the frame through which the stringer passed. However, as shown in figure 14(b) the failures were still near the point of load application (approximately 11 degrees) and at other circumferential locations of approximately 45 to 67 degrees. In the absence of skin material, twisting and bending out-of-plane occurred with the frames. The stringers had only a minimal effect on the subfloor response and that was to maintain the lateral spacing of the three Z-frames.

Figure 14. - Behavior of composite skeleton subfloor under static loading tests.

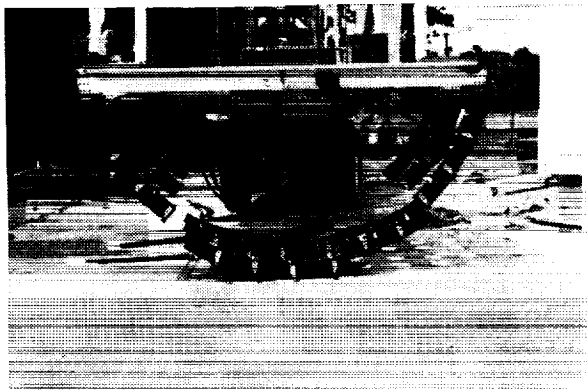
(a) Failed composite skeleton subfloor.

Dynamic tests. A photograph of a skeleton subfloor after an impact test onto a concrete surface at 20 feet per second is shown in Figure 15. In the dynamic test of the skeleton subfloor, fractures were produced at notches in the frames (Figure 15(a)). The locations, shown in figure 15(b), were also near the point of impact (about 11 degrees because of the splice plate) and at three other locations up the circumference of the frames (55 degrees and 78 degrees) totalling 15 fractures for all three frames. The impact energy exceeded the energy absorbed by the local fractures and the floor bottomed out during the impact. The normalized circumferential strain distribution measured on the flange of the front frame during the dynamic test just before first failure is shown in Figure 15(c). A comparison of the measured distribution to the predicted moment distribution of Figure 12(b) and (c) shows essentially identical shape between the single frame and skeleton frame distributions. Maximum values at 0 degrees and at approximately 50 to 55 degrees for the experiment agree well with the analytically predicted locations on the frame.

Figure 15. - Behavior of composite skeleton subfloor under dynamic loading tests.

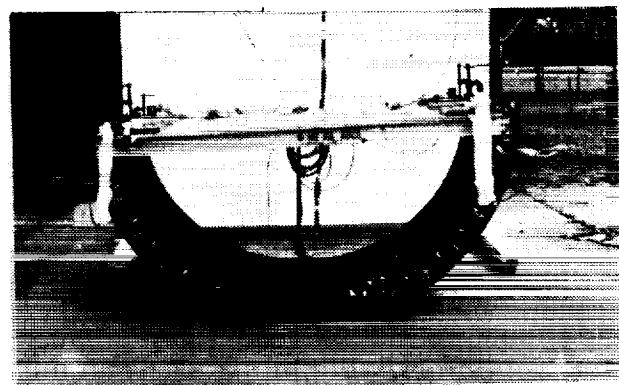
(a) Failed composite skinned subfloor.
Frame A (Front)

Impact results for the subfloor with skin after an impact of 20 feet per second are shown in Figure 16. A photograph of the subfloor specimen after the test is shown in Figure 16(a). Points of failure of the frames in this specimen are indicated in figure 16(b). Again the points of failure are at or near the impact point (within 12 degrees) and circumferentially at about 56 degrees up both sides of the frame on the middle and back frame and 45, 12 and 22.5 degrees on the front frame. It was observed that the subfloor impacted first on the front area which possibly explains the 12 and 22.5 degree fractures being different from the other locations. Again all three frames were involved in the failures. Some delamination of the frames from the skin was evident but the skin remained intact. Normalized strain distribution (just prior to first failure) measured on the skin at the location of the front frame during the dynamic test showed essentially identical shape as the single frame and skeleton frame distributions. As was the case for the skeleton subfloor maximums at 0 degrees and at approximately 50 to 55 degrees for the experiment agree well with the analytically predicted locations on the frame.

Figure 16. - Behavior of composite skinned subfloor under dynamic loading tests.

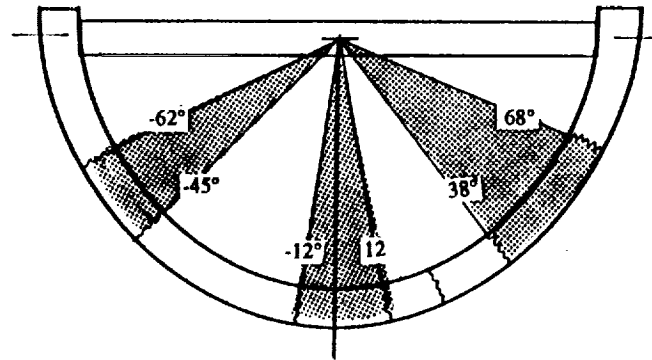
(b) Failure locations.

The response behavior determined during the studies of full-scale aircraft sections, fuselage frames, and subfloors are summarized in figure 18. Normalized moment distribution on a representative frame of the various specimens are shown in Figure 18(a). Figure 18(b) shows the failure locations which were noted from static and dynamic tests. The visual impression is quite striking among the various specimens. The structures all share in common the generally circular or cylindrical shape, the normal loading situations, and what appears to be a similar pattern of failure behavior. Analytical models of frame structures under vertical loads have moment distributions which have maximums at the point of loading and at approximately 45 to 50 degrees (depending on boundary conditions) around the circumference from the ground contact point. Failures of the structures were noted at these same locations. Such observations may help dynamists gain a clearer understanding of what to expect from such structures in crash loading situations, may guide designers of new structures to account for the vertical crash loads, and allow increased energy absorption to be included in the new designs. Additionally, the observations may help analysts to model the aircraft structures more adequately for predicting the failure responses and behavior under crash situations. The latter task is a difficult and challenging one, not only for composite structures but for metal structures as well. Studies are currently underway to improve the analysis capabilities of current codes and to add composite elements to finite element libraries such as the DYCAST program. In addition, new analysis approaches are being explored through grants to universities as an extension of NASA Langley Research Center's in-house efforts.

Figure 18. - Comparison of non-dimensional analytical moment distribution predicted by finite element frame model and observed failure locations on metal and composite fuselage components and structures.
